Case Study

Linear Profile Rail Guide

5 times longer service life achieved and still running

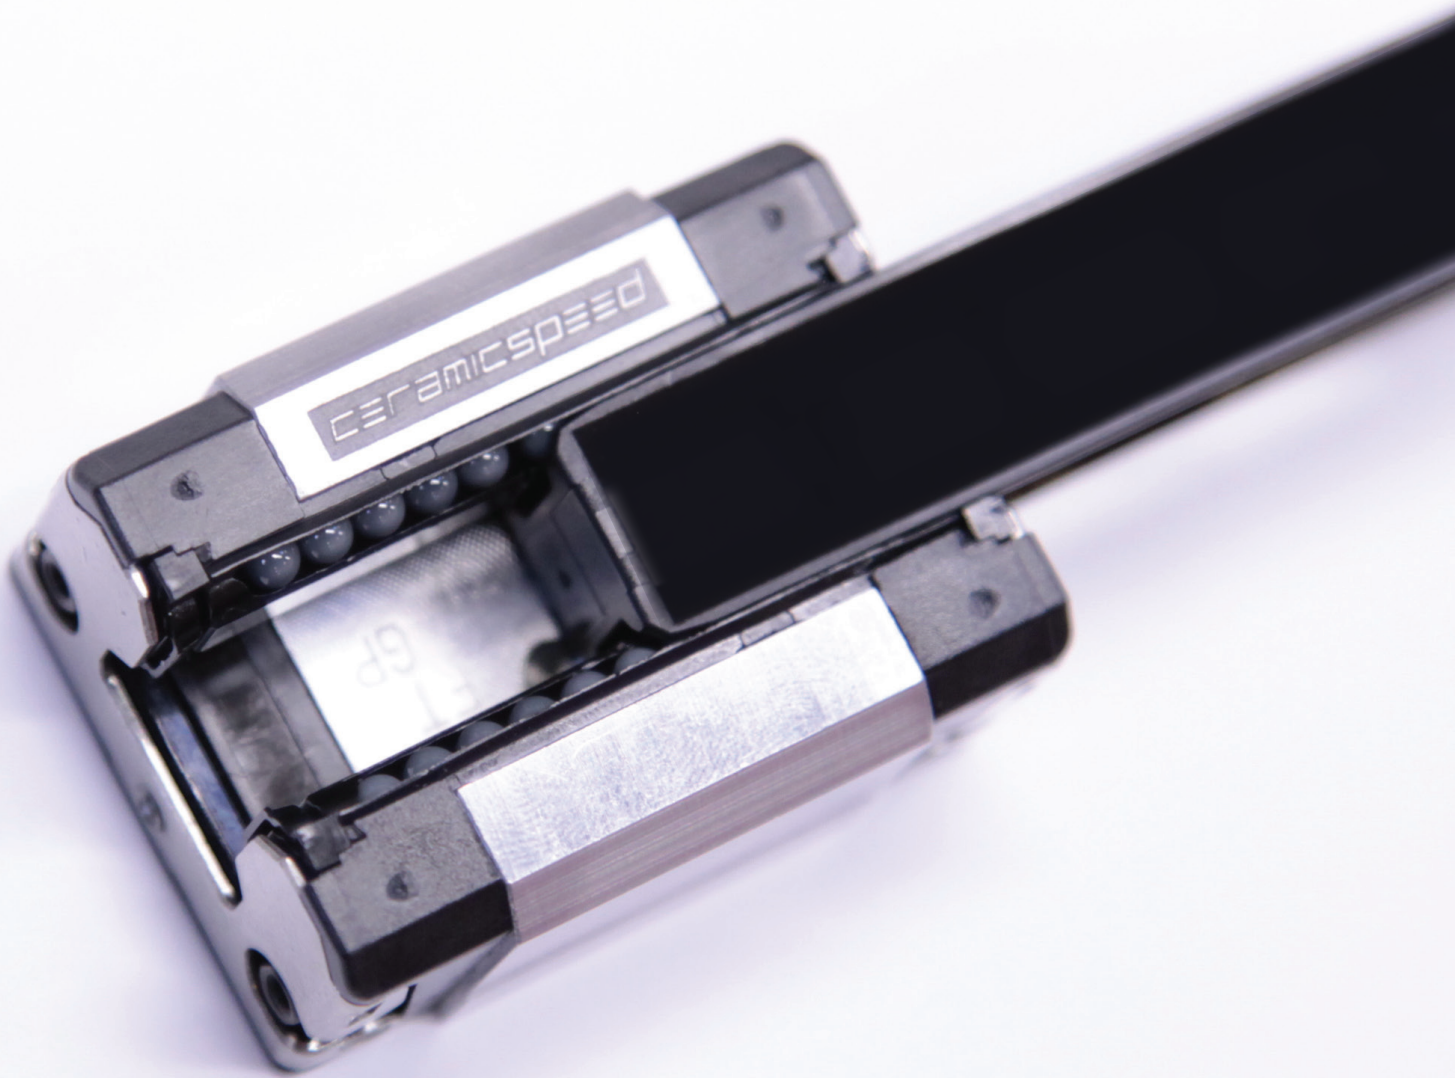
This automated packaging system is placed at one of Denmark's largest dairies and fits cartons with fresh milk into wheeled cages ready to go directly to the retailers.

Due to the moist environment and frequent wash downs, the linear components suffered from corrosion issues as well as scarcity of lubricant. The original rails would wear down and become noisy and imprecise already after 12 – 18 months of service forcing a production stop and an expensive repair operation.

CeramicSpeed Xtreme Linear Guide are fitted with FDA approved grease and premium-quality ceramic (Si₃N₄) balls which are 2 times harder than steel, 4 times smoother and need much less lubrication.

As the ceramic balls will never corrode, the production stops costed by linear guiding failure has now been eliminated, and further the contact between the smooth ceramic balls and the hardened stainless steel rail causes much less wear than the traditional steel/steel contact, which prolongs service life of both parts of the system dramatically. The first CeramicSpeed upgrade that was installed is still in service after now 8 years of operation.
