Case Study

Linear Carriage and Rails

3 times longer service life achieved and still running

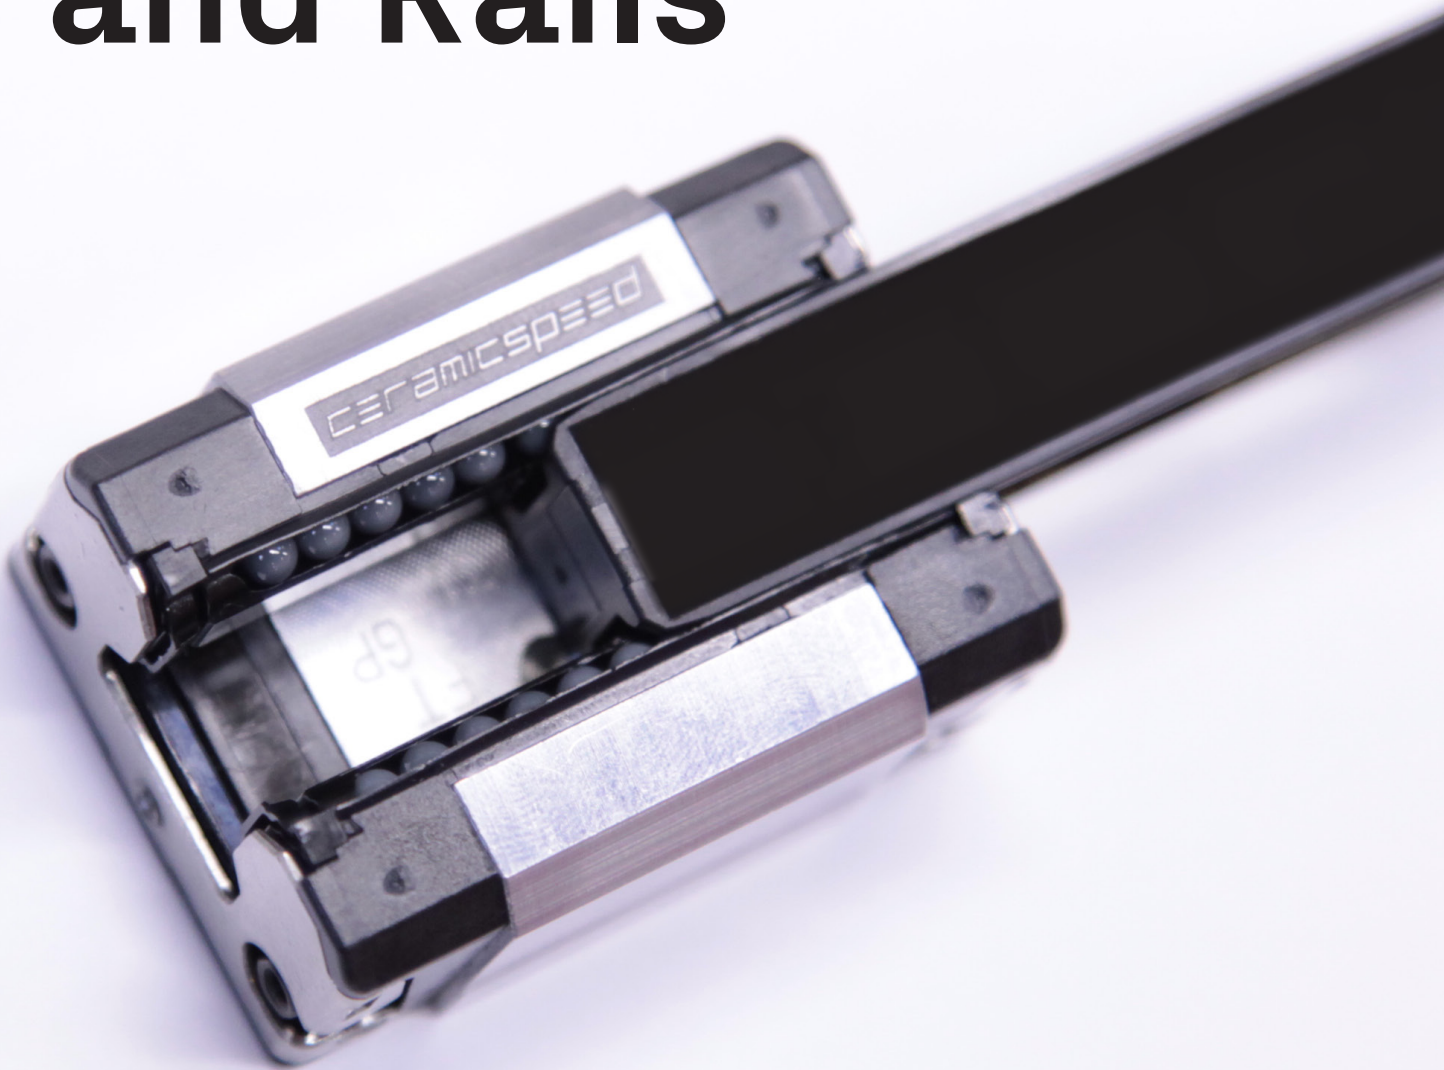
This automated packaging system is placed at one of Denmark's largest dairies and fits cartons with fresh milk into wheeled cages ready to go directly to the retailers.

Due to the moist environment and frequent wash downs, the linear components suffered from corrosion issues as well as scarcity of lubricant. The original rails would wear down and become noisy already after 12 – 18 months of service forcing a production stop and an expensive repair operation.

CeramicSpeed Longlife Corrotec bearings are fitted with FDA approved grease and premium-quality ceramic (Si₃N₄) balls which are 2 times harder than steel, 4 times smoother and need much less lubrication. CeramicSpeed hybrid bearings have a much lower friction coefficient which reduces bearing temperatures and power consumption.

As the ceramic balls will never corrode, the production stops costed by bearing failure has now been eliminated, and further the contact between the smooth ceramic balls and the steel rail causes much less wear than the traditional steel/steel contact, which prolongs service life of both parts of the system dramatically. The first CeramicSpeed upgrade that was installed is still in service after now 6 years of operation.
