Case Study

Rinsing Station

Running submerged in acetone without any problems

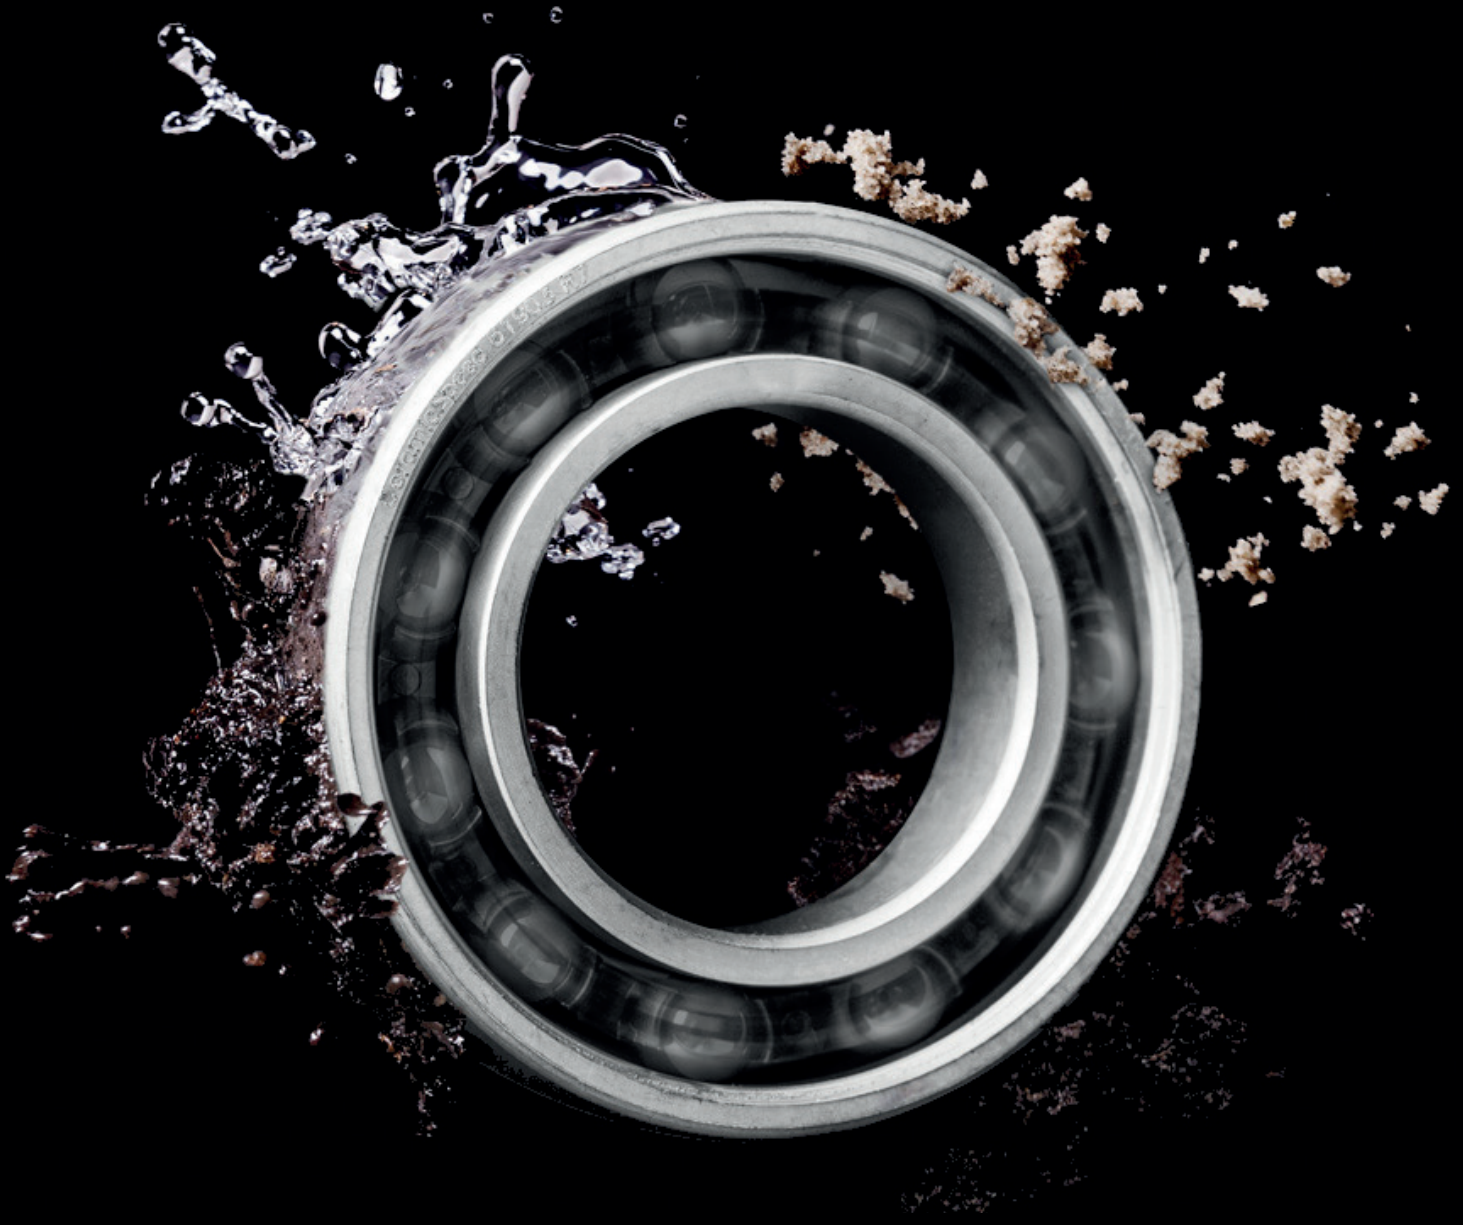
This Production line runs 24/7 producing filter membrane by the meter. The final step in the process is a cleaning section in which the membrane fabric is rinsed thoroughly to meet food grade cleanliness.

Half of the bearings installed in this section are running submerged in a water-acetone solution, which can only be described as a directly hostile environment for any bearing installation. The service life of the standard steel bearings in this application was therefore very short - mostly down to under two hours. This had a huge effect on the maintenance costs along with loss of production.

CeramicSpeed SLT is a polymer matrix saturated with lubrication oil. The matrix retains oil right on the functional surfaces of the bearing under even very harsh conditions while at the same time preventing moist and foreign particles in entering the bearing.

By replacing standard steel bearings with CeramicSpeed SLT bearings our customer achieved a much longer service life and a remarkable reduction of the maintenance costs.

The CeramicSpeed SLT bearings have now been running submerged in acetone for 8 months without any problems.

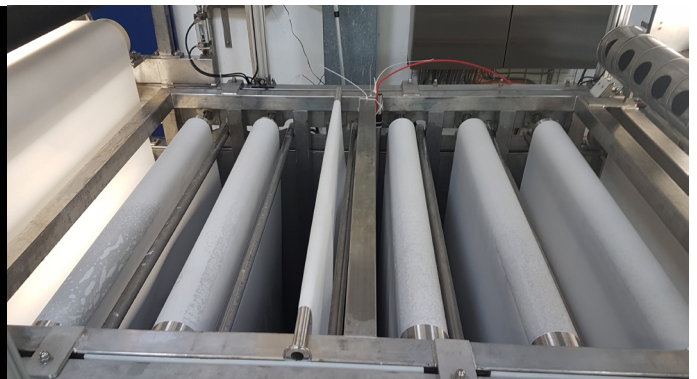
Technical Highlights

- Extremely harsh environment
- Slow speed - moderate load
- Bearing temperature: 20°C-80°C
- Running 24/7
