Case Study

# Mast Roller

# 7-12 times longer service life in very harsh environments

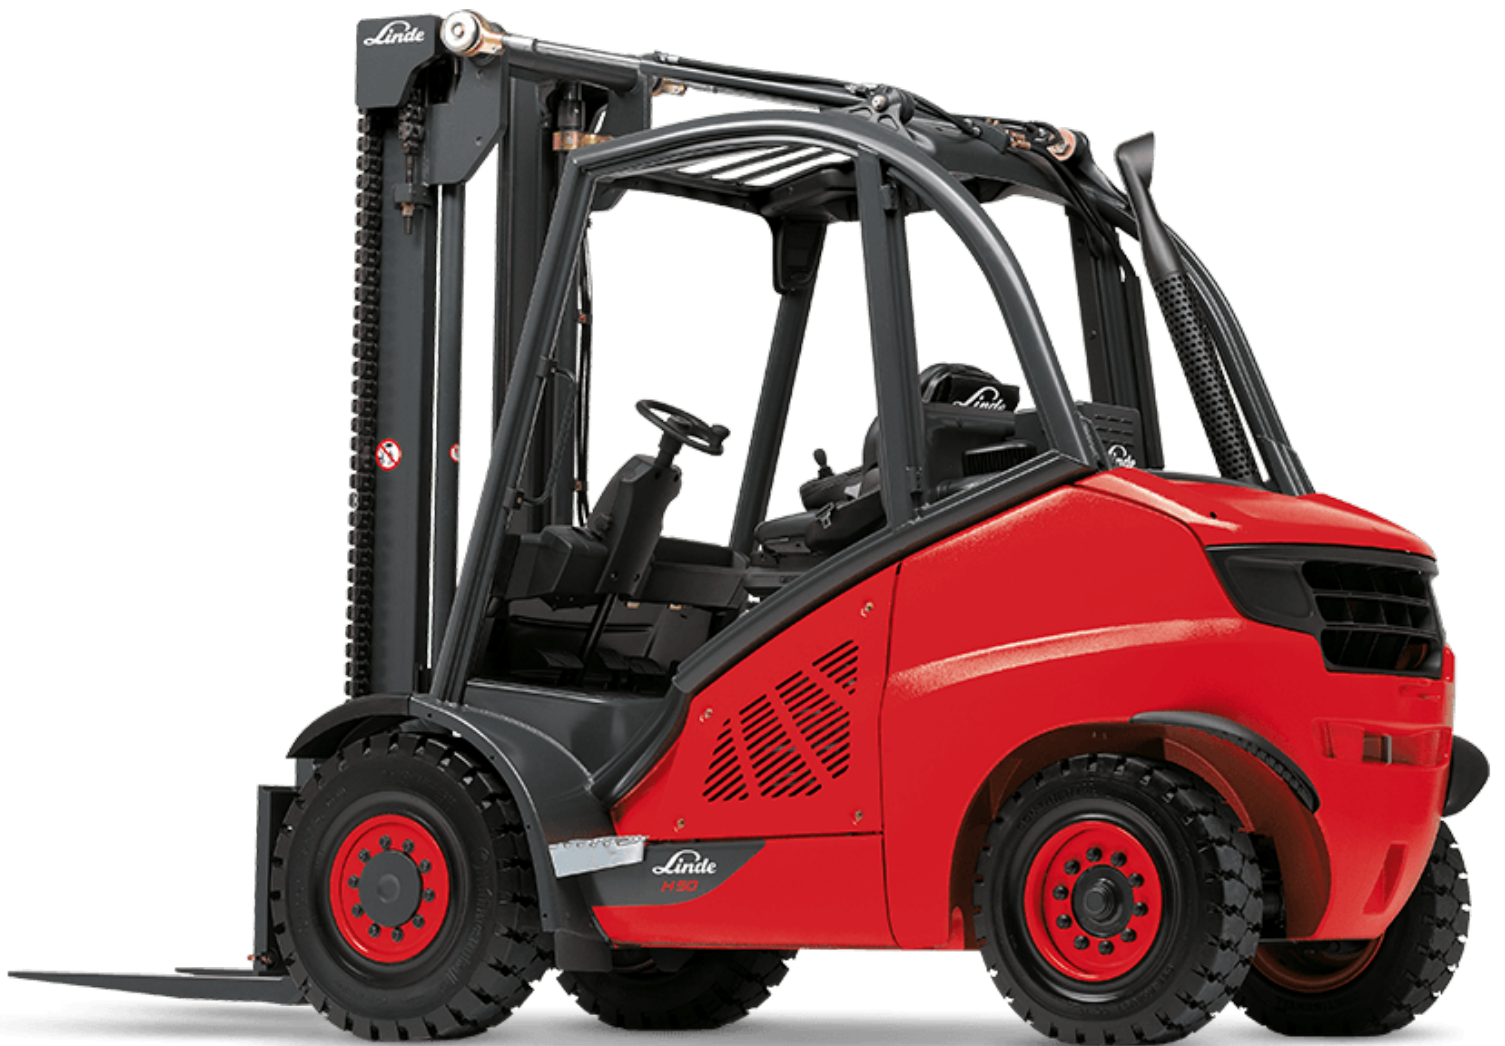
Mast roller in trucks often operate in very harsh environments. The large wear and the fast decay of the bearing often occur with insufficient lubrication due to low rpm, frequent start/stops, rotation both ways and shocks.
