Case Study

# Linear Carriage and Rails

# 3 times longer bearing life achieved and still running

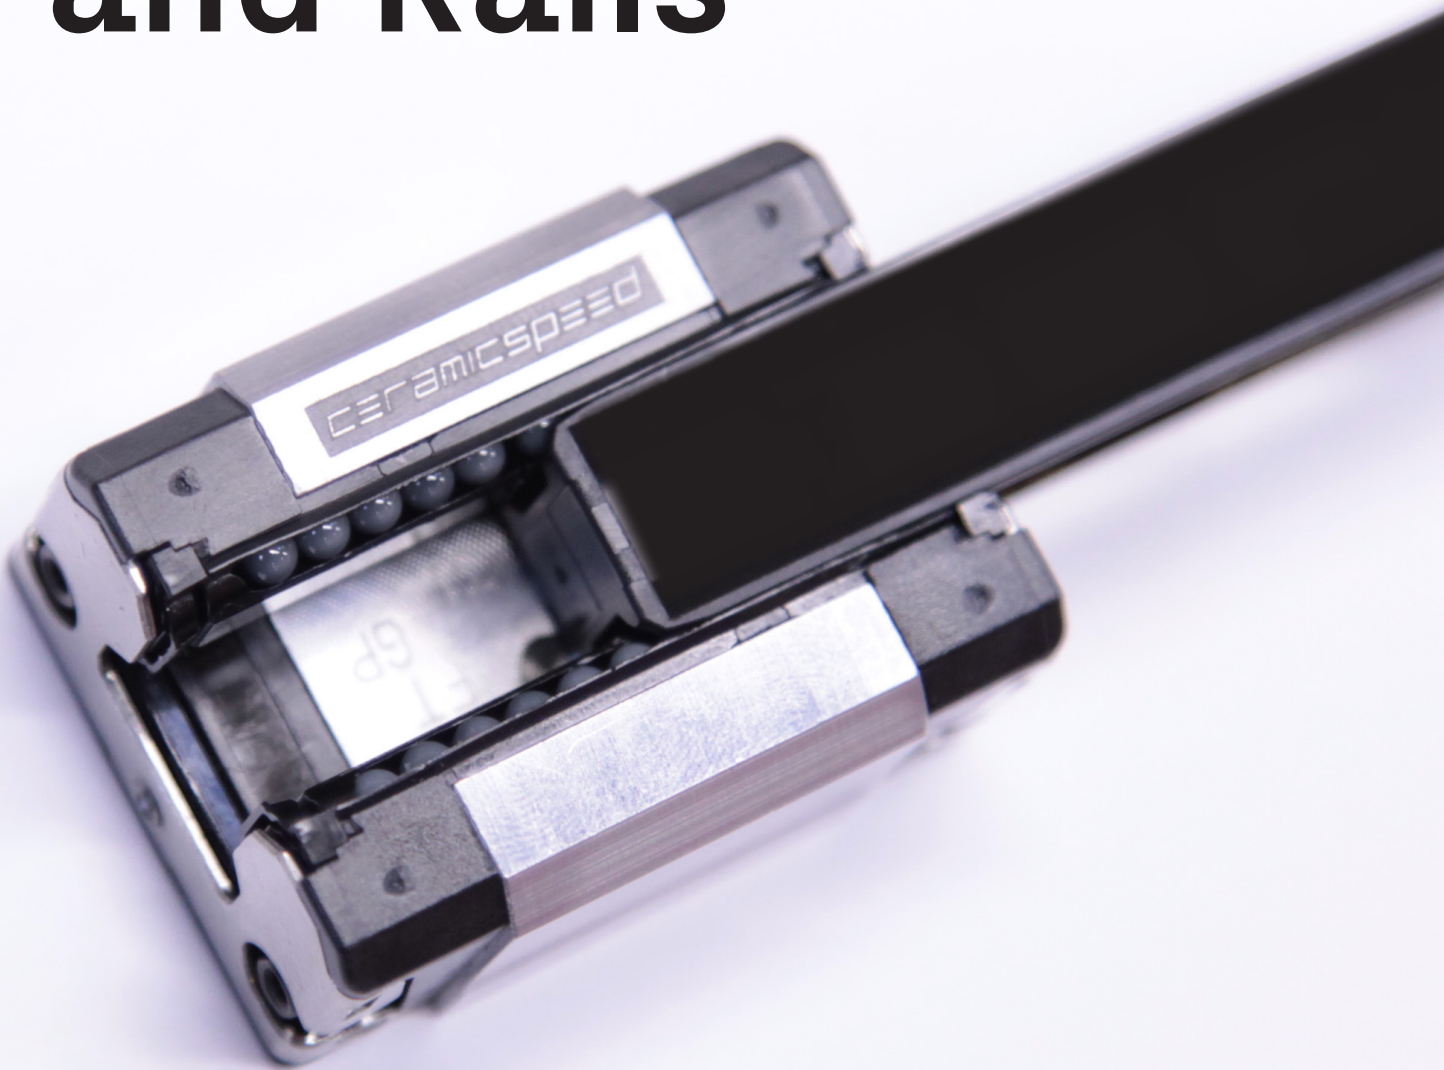
This automated packaging system is placed at one of Denmark's largest dairies and fits cartons with fresh milk into wheeled cages, ready to go directly to the retailers.

Due to the moist environment and frequent wash-downs, the linear components suffered from corrosion issues, as well as a scarcity of lubricants. The original rails would wear down and become noisy already after 12 – 18 months of service, forcing a stop in production and an expensive repair operation.

CeramicSpeed Longlife Corrotec bearings are fitted with FDA-approved grease and premium-quality ceramic ( $\text{Si}_3\text{N}_4$ ) balls, which are 2 times harder than steel, 4 times smoother and need considerably less lubrication. CeramicSpeed hybrid bearings have a much lower friction coefficient, which reduces bearing temperatures and power consumption.

As the ceramic balls will never corrode, a lack of stops in production translates to lower costs, and furthermore the contact between the smooth ceramic balls and the steel rail causes much less wear than the traditional steel/steel contact, which prolongs bearing life of both parts of the system dramatically. After 6 years of operation, the first CeramicSpeed upgrade that was installed is still in service.

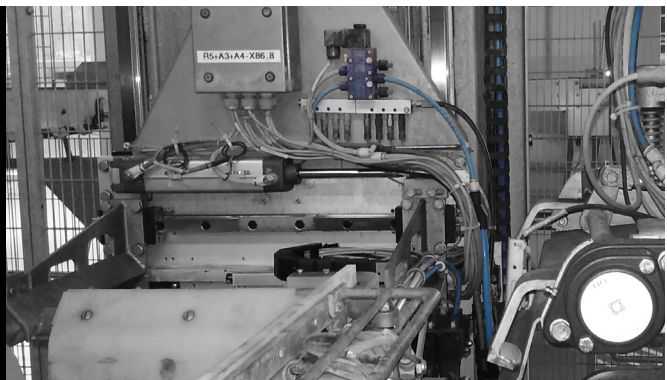
- Slow reciprocating movement
- Bearing temperature: 4°C-8°C
- Lubrication: Food grade oil
- Environment: Low temp., high moist
